LOWE'S
Home Improvement Warehouse

*Geotechnical Engineering &
Phase I Investigation*

**Owner: Lowe's Companies, Inc.
Location: Murray, Kentucky**

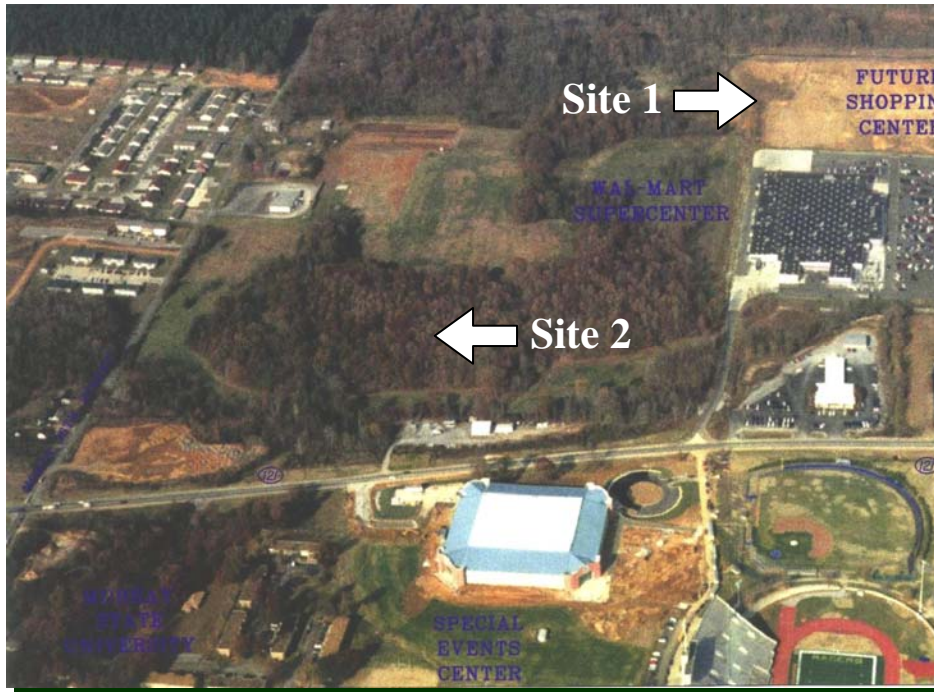
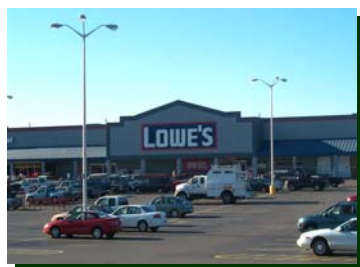
Alternate sites were investigated for the presence of recognized environmental conditions, wetlands and geotechnical factors. Exploration of Site 1 focused on the evaluation of the quality and composition of the existing site fill. Discovery of a random fill zone in the vicinity of the original creek alignment resulted in the subsequent evaluation of a second site.
